st Report	No.:	SHAEC22002615303	Date:	Oct 24, 2	022 Page 1 of 4
Client name : Wuxi :	xingd	a new poam plastics materia	lls co.,ltd		
Client address : 88 xiga	ang F	RD(S)dong gang town xishan	district, Wl	JXI, jiangsı	ı,chin
Sample Name	:	PKF			
The above sample(s) and	infor	mation were provided by the	client.		
SGS Job No.	:	SP22-024155			
Sample Receiving Date	:	Oct 18, 2022			
Testing Period	:	Oct 18, 2022 - Oct 24, 2022	2		
Test Requested	:	Select test(s) as requested	by the clier	nt.	
Test Method(s)	:	Please refer to next page(s).		
Test Result(s)	:	Please refer to next page(s).		
Test Requirement					Conclusion
Halogen					See Results

Test Report

No.: SHAEC22002615303

Halogen

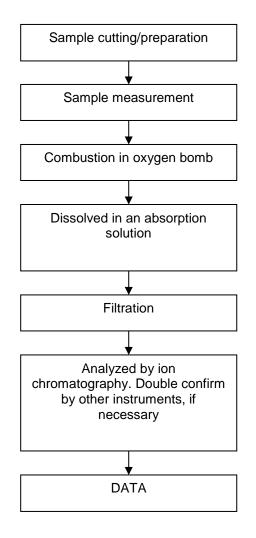
Halogen Testing (oxygen bomb) Flow Chart

Test Method: With reference to EN 14582:2016, analysis was performed by IC.
